# Trimax Merlin 320 Mower Trial

## Introduction

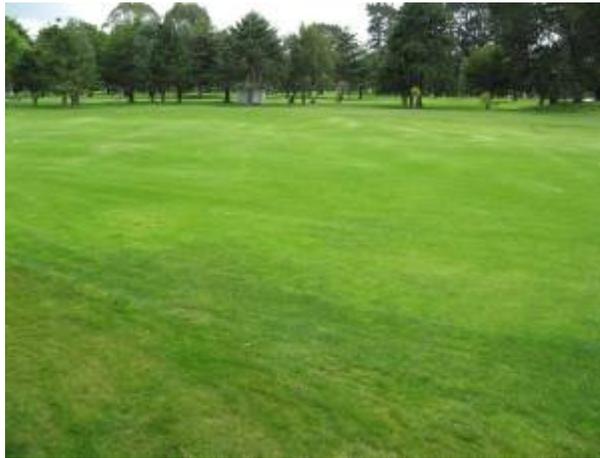
**Figure 2:** 17th fairway looking across towards the 3rd fairway, area cut by the Merlin 320

The first section of the 17th fairway, from tee to the set of bunkers was mown with Merlin 320. The second section of fairway from the managed rough to the green approach was mown with a reel mower (control). The first part of the 17th fairway contains a number of sharp undulations and small mounds, and provides a challenging surface from a mowing perspective, regardless of the design of the fairway mower (Figure 2). The second part of the fairway is more gently rolling in nature.

The cut height of the Merlin 320 was adjusted to match that of the control mower. In addition, soon after the first cut with the Merlin 320 some additional anti-bounce skids were

attached to the mower to help prevent the slight scalping that was occurring on some of the sharper mounds.

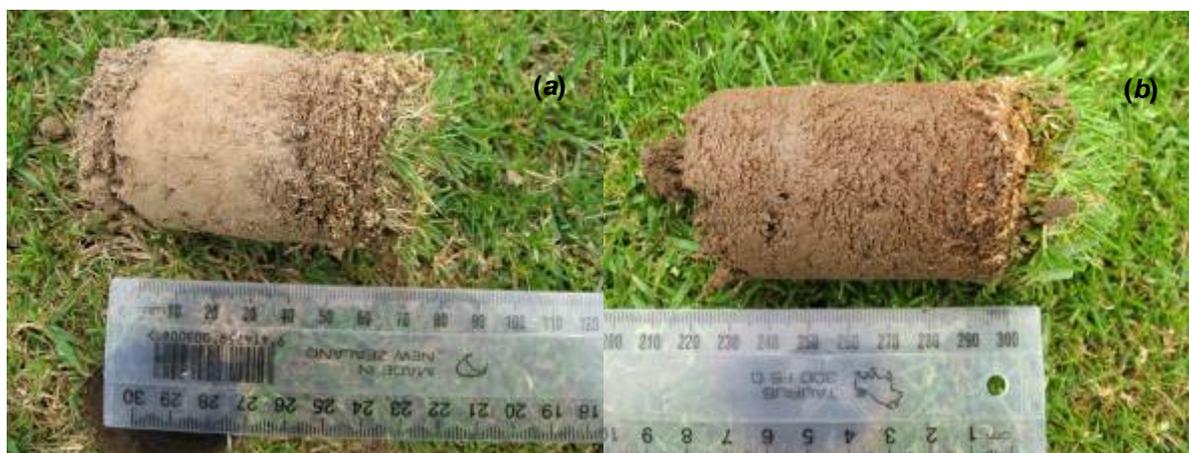
**Figure 4:** Moisture difference in dry patch affected turf (a) versus green healthy turf (b) unaffected by dry patch

Overall turf quality was assessed of each assessment area every two to three weeks. There was a general decline in turf quality over the trial period for both the Merlin 320 mown section of fairway and the control (Table 1). However, none of this decline was related to the mowing itself, but was due to the presence of 'dry patch' of both fairway areas. Figure 3 shows a series of photographs illustrating the decline in turf quality over trial period. The brownish/grey patches are due to dry patch. Dry patch regularly occurs in these areas during the hot and dry summer weather. Dry patch was confirmed as the cause of the decline in turf quality scores by taking soil cores from the dry patch affected areas visually comparing the moisture content with an unaffected area (Figure 4).

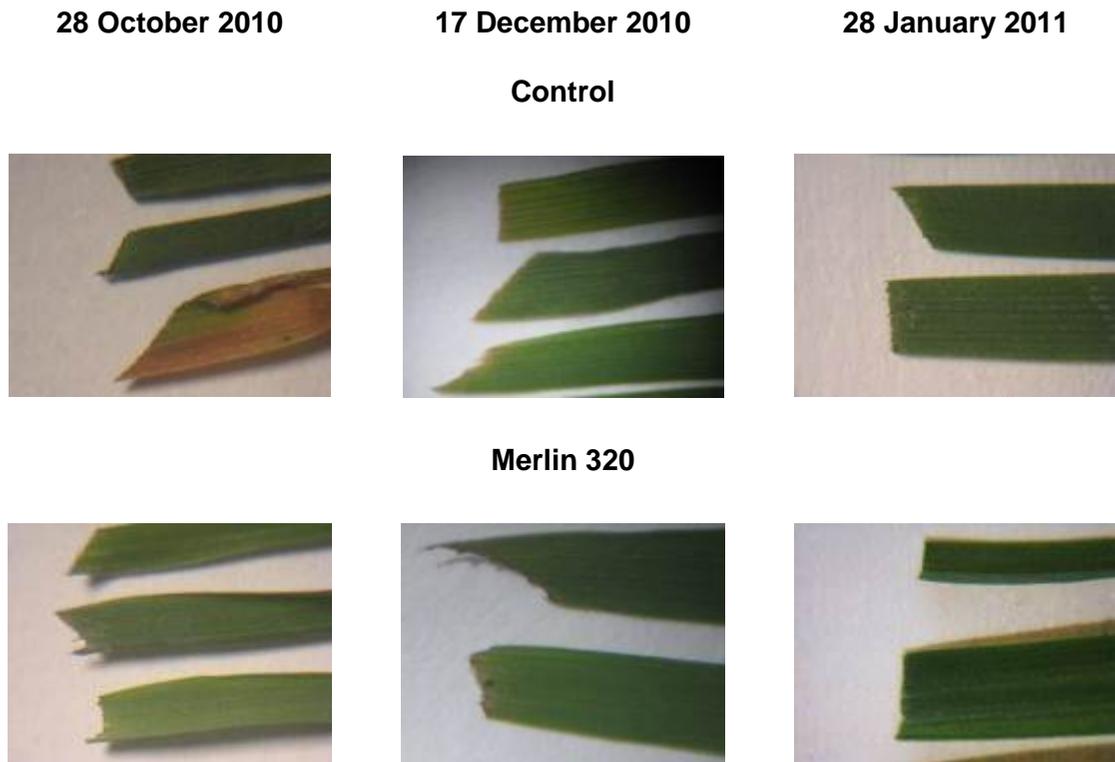
**Figure 8:** Cleanness of cut as taken through a dissecting microscope

Cut quality of individual leaves was more closely examined under a dissecting microscope to look for differences in cut quality. Photographs were taken down the microscope and those from three dates are presented in Figure 8. From these examinations and from the photographs in Figure 6, it was observed that the cleanness of cut of the Merlin 320 was very similar to that of the control mower.

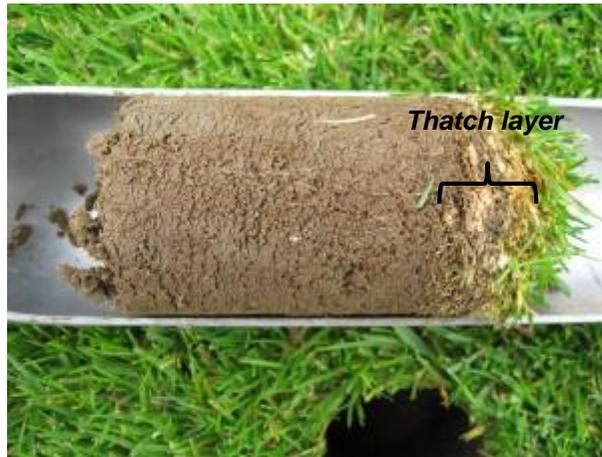
**Figure 9:** Example of thatch layer under the 17th fairway

Thatch depth was measured on three occasions during the trial. Thatch is the layer of undecomposed plant material immediately below the green grass plant (Figure 9). Thatch depths were highly variable across each fairway area with a range of 12 mm. Mean thatch

depths did not change over the period of the trial. In addition, there was also no increase in the depth of thatch due to the use of the Merlin 320 mower

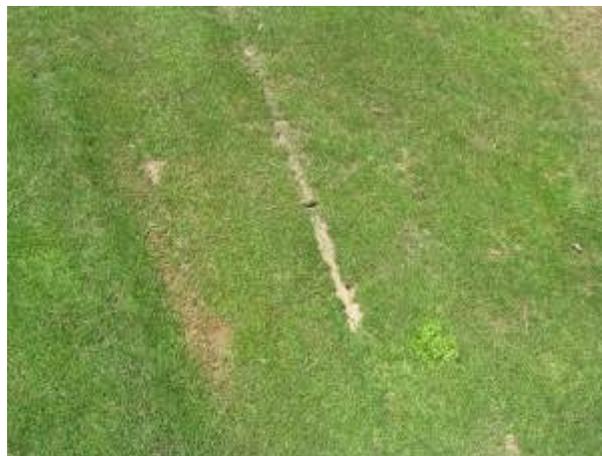
**Figure 10:** Anti-bounce skid damage from Merlin 320

During the assessment of the 17 January along narrow scuff mark was noticed near the first assessment area being cut with the Merlin 320 mower (Figure 10). This area consists of a fairly 'sharp' mound that was slightly scalped during the first mow with the Merlin 320. The course Superintendent advised that it was due to one of the skids on the Merlin 320 digging into the turf surface. The damage occurred when the mowing direction was changed and after a period of wet weather prior to Christmas. The anti-bounce skid has dug in when the tractor has moved up onto the top of the mound. This particular mound rises up from the surrounding fairway by 300-330mm over a distance of approximately 2.5m (slope of 12 – 13%).
