# Trimax Merlin 320 Mower Trial

## Introduction

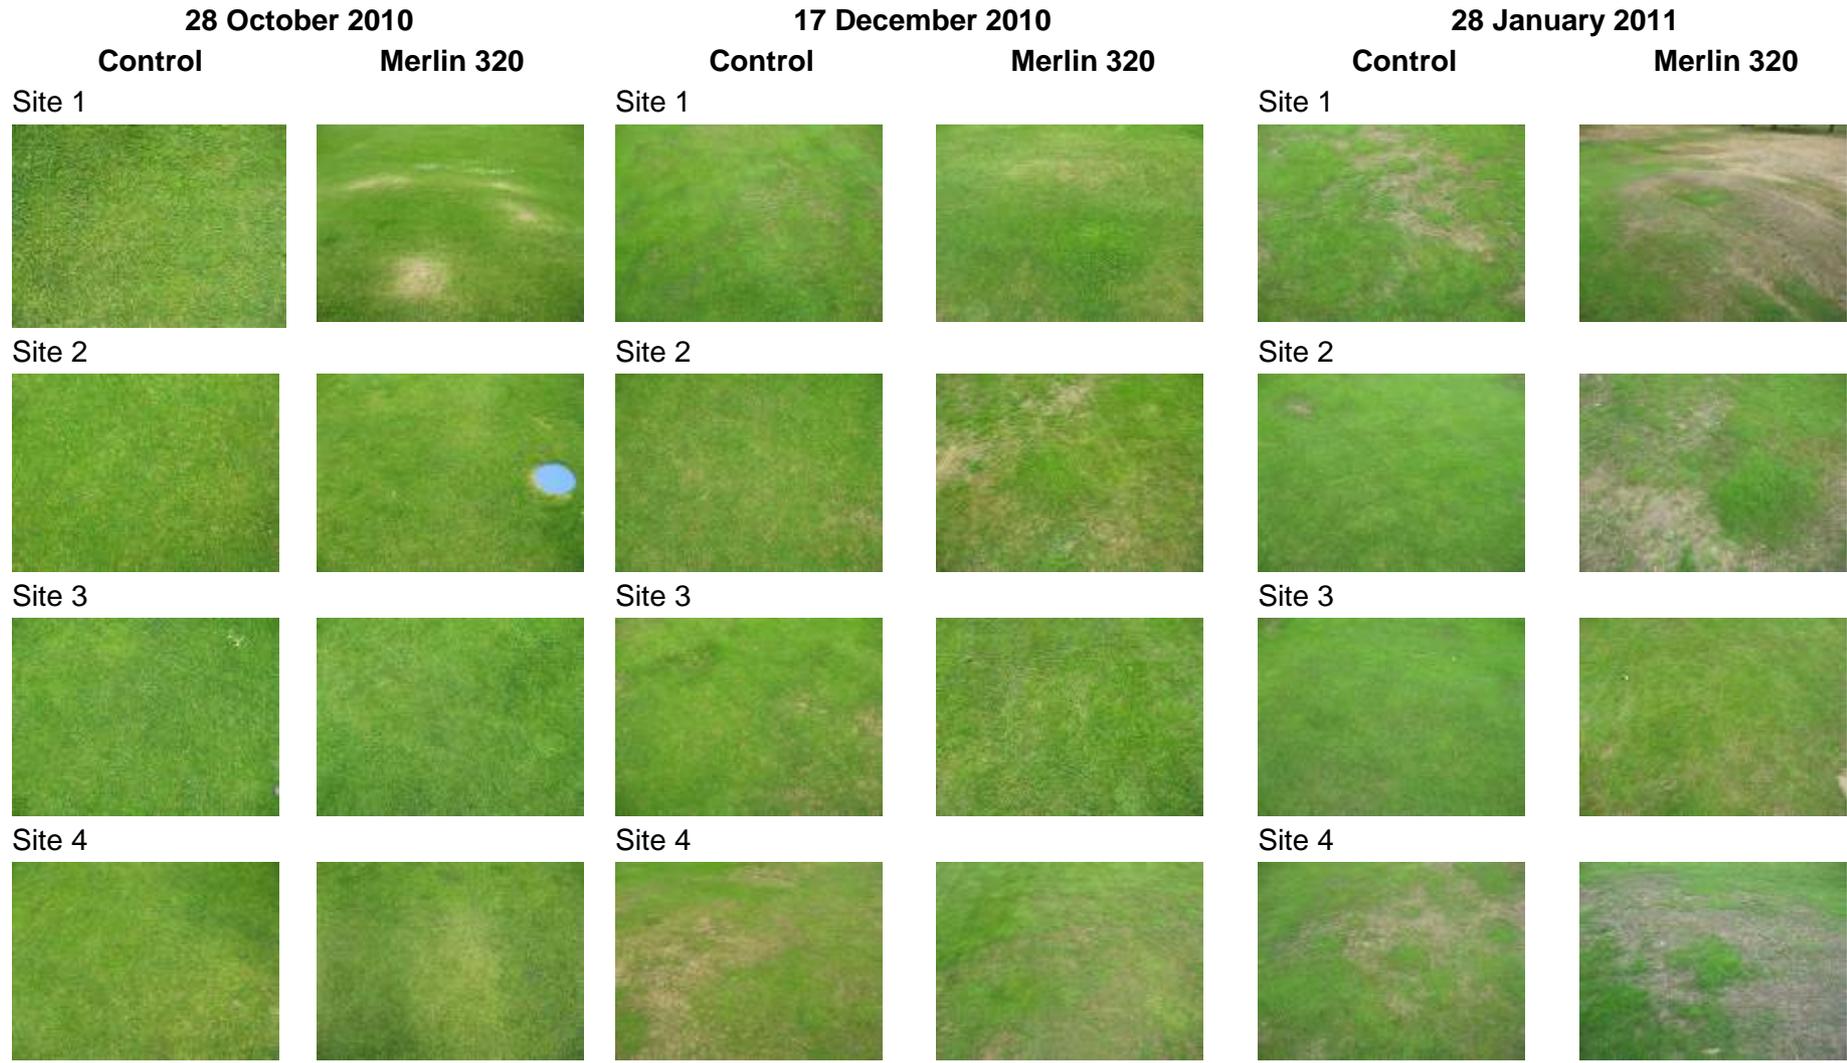
**Figure 3:** Turf quality on three assessment dates

Overall turf quality was assessed of each assessment area every two to three weeks. There was a general decline in turf quality over the trial period for both the Merlin 320 mown section of fairway and the control (Table 1). However, none of this decline was related to the mowing itself, but was due to the presence of 'dry patch' of both fairway areas. Figure 3 shows a series of photographs illustrating the decline in turf quality over trial period. The brownish/grey patches are due to dry patch. Dry patch regularly occurs in these areas during the hot and dry summer weather. Dry patch was confirmed as the cause of the decline in turf quality scores by taking soil cores from the dry patch affected areas visually comparing the moisture content with an unaffected area (Figure 4).

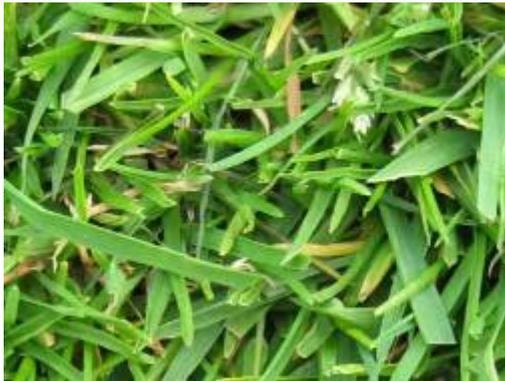
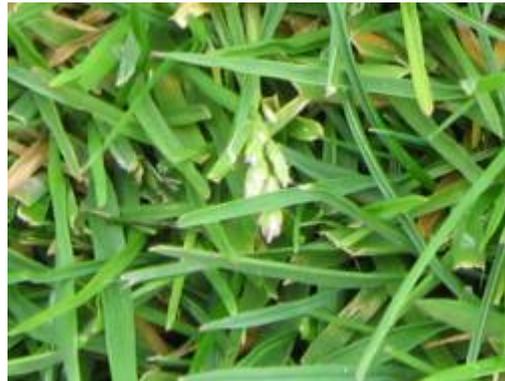
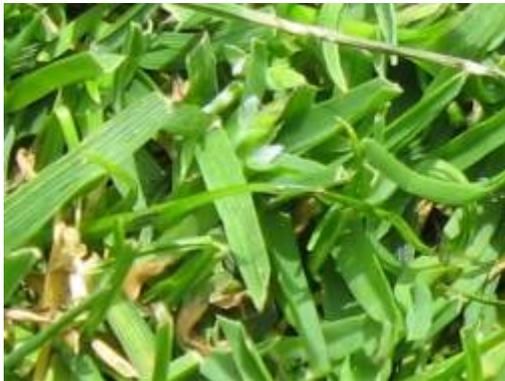
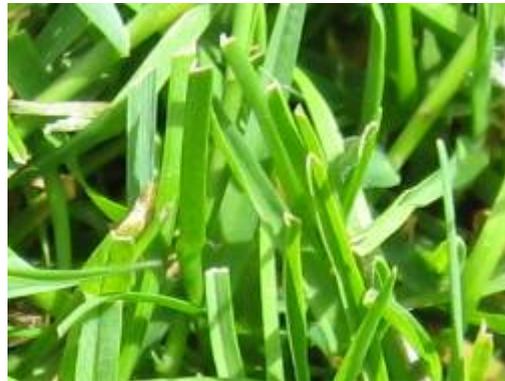
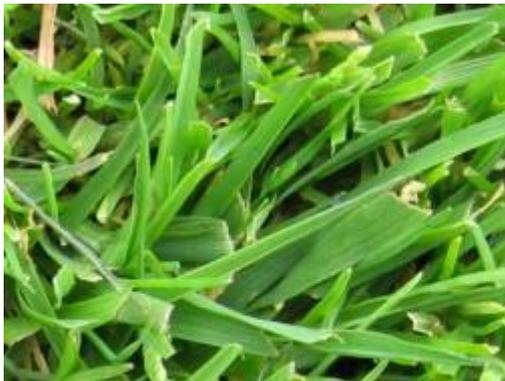
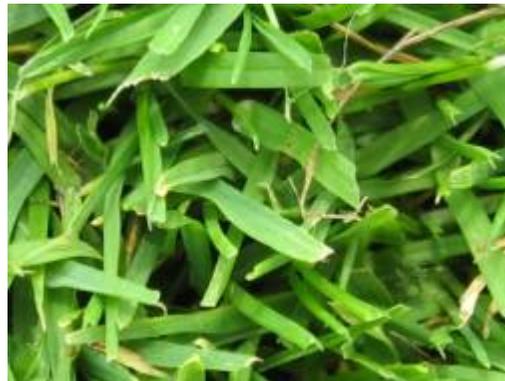
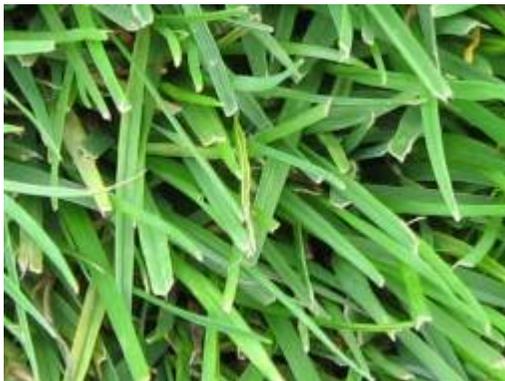
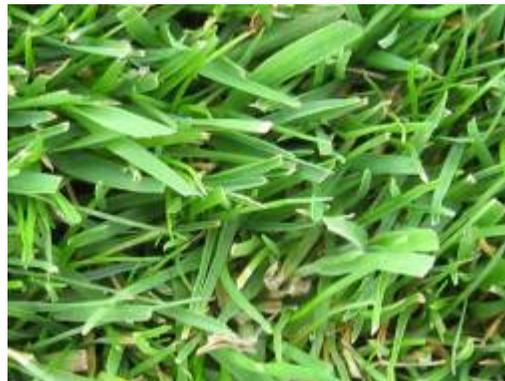
**Figure 6:** Cut Quality on four assessments dates

Cut quality of individual leaves was more closely examined under a dissecting microscope to look for differences in cut quality. Photographs were taken down the microscope and those from three dates are presented in Figure 8. From these examinations and from the photographs in Figure 6, it was observed that the cleanness of cut of the Merlin 320 was very similar to that of the control mower.

There were no significant differences in the cut quality in terms of shredding, rough cut edges or turf die back between the Merlin 320 rotary mower and the control (reel type) mower. Only after the first cut, of a particularly 'sharp' mound was there any damage due to mowing with the Merlin 320 mower and this consisted of only some minor scalping. Scalping did not reoccur after anti-bounce skids were added to the Merlin. Similarly, there were no significant differences in overall turf quality between the two mowers. In the three months over which the trial was conducted there were also no changes in thatch depth between the two mowers.
